VIETNAM AGEING STUDY MANAGEMENT OF EXPLOSIVE REMNANTS OF WAR (MORE)

GENEVA INTERNATIONAL CENTRE FOR HUMANITARIAN DEMINING Vietnam ageing study - Management of explosive remnants of war (MORE), GICHD, Geneva, 2019 ISBN 978-2-940369-77-5 © GICHD

This report presents the results of a pilot study conducted in 2018 and provides comment on the technical ageing of ERW found in Vietnam, to determine the effect of time and surrounding environment on the probability of detonation and functionality, on a limited number of target items.

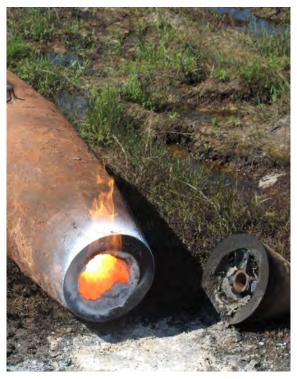
The burned-out carcass of the Mk 84 bomb as it cooled. Note that the fuze in the nose section (to the right) has been deliberately initiated using the heat of the burn, in order to render it safe

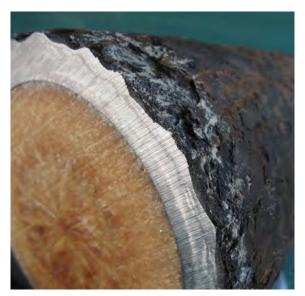
The corrosion of thick steel casings is normally superficial, but may make it hard to measure the calibre

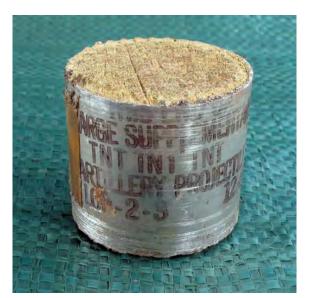
A pressed booster from a US artillery projectile, still in exceptionally good condition

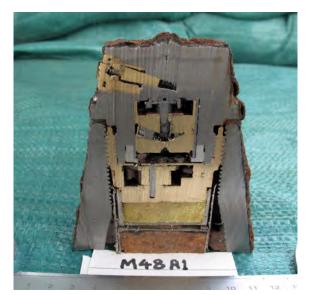
A sectioned M48A1 fuze from an M107 projectile

A brief examination of the fuzes, as shown here, appears to support this finding. However, a good deal of further analysis would be needed in order to establish more detailed conclusions on the failure mechanisms of individual weapons, and their implications for residual risk.

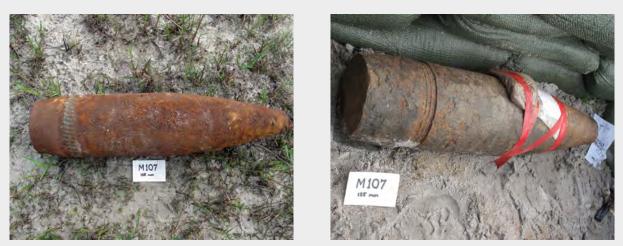
The engraved driving band on the left hand projectile (#8) clearly shows that it has been fired. The driving band on the right-hand projectile (#9) has been removed, probably for its scrap value

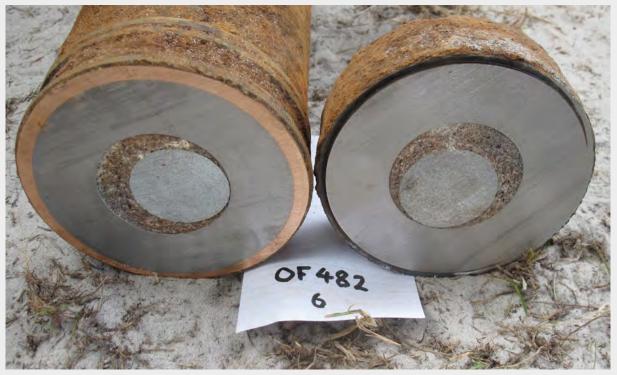
A section through the base of a 130 mm OF 482 projectile showing (left, from the outside moving inwards) the copper driving band, the thick steel casing of the base section and the lower extremity of the main charge, with embedded aluminium-based incendiary pellet

This section, once again, demonstrates the utility of cutting in order to visualise components, and their relationship to one another. For example, diagrams - or even X-rays - might not reveal that the incendiary pellet is often off-centre.

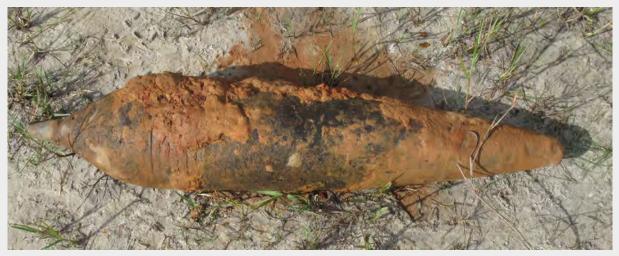
The F-853U mortar bomb presented for cutting. The body shape is distinctive enough to allow for identification despite the absence of the tail assembly; however, the missing tail makes it harder to establish whether the mortar bomb was unfired or unexploded

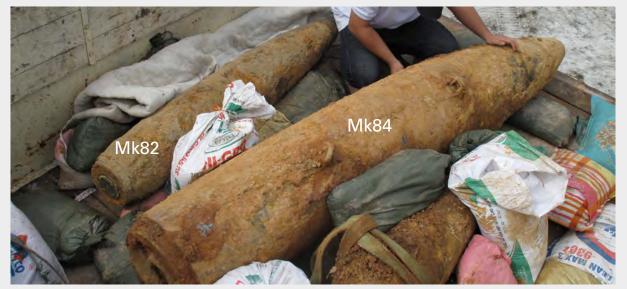
The Mk 84 bomb, along with two Mk 82 bombs, being delivered to the site. All of the bombs were fitted with an M904 nose fuze and no tail fuze. Tail assemblies were missing, as is often the case; these tend to become detached as the bomb enters the ground

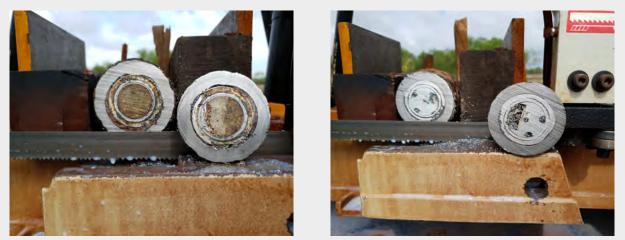
Views of the cut of the US M525 PD fuze and the booster cup section of the M374 81 mm mortar; note the damage and expansion due to corrosion of the aluminum of the fuze

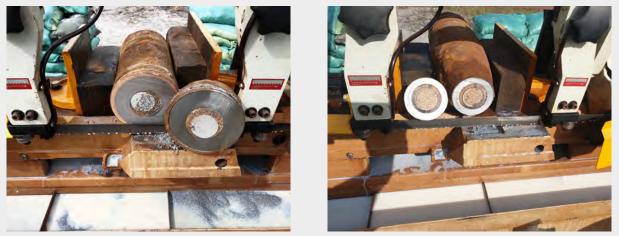
The base cut of the OF 482M 130 mm projectile showing the TCU incendiary plug embedded within the TNT filler. Also pictured is the M107 155 mm projectile with the cut at the booster cup and its HE filler

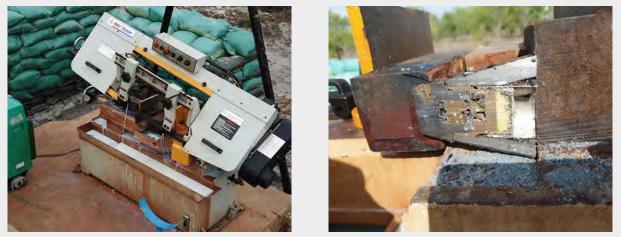
Drone view of the cutting of the M107 155 mm projectile; image on the right shows the result of the cut of the M48 series PD fuze that was on the fired M107 155 mm projectile
