VIETNAM AGEING STUDY MANAGEMENT OF EXPLOSIVE REMNANTS OF WAR (MORE)

GENEVA INTERNATIONAL CENTRE FOR HUMANITARIAN DEMINING Vietnam ageing study - Management of explosive remnants of war (MORE), GICHD, Geneva, 2019 ISBN 978-2-940369-77-5 © GICHD

This report presents the results of a pilot study conducted in 2018 and provides comment on the technical ageing of ERW found in Vietnam, to determine the effect of time and surrounding environment on the probability of detonation and functionality, on a limited number of target items.

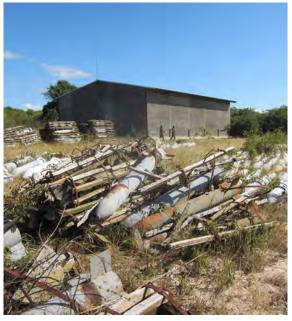
Whether abandoned or expended, Cold War era ammunition throughout the world is suffering from the effects of ageing

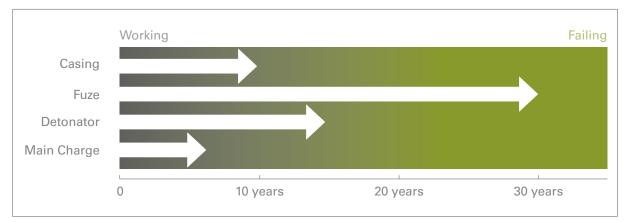
Critical components transition from full functionality to failure at different rates

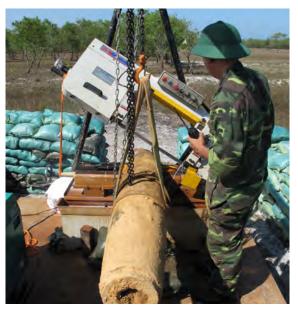
A Vietnamese soldier from BOMICEN sets up a cut on a US Mk 82 aircraft bomb

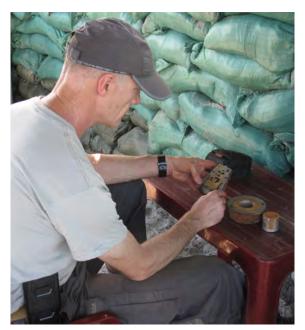
Cut munitions were taken to a separate tent, well away from all other activity, for examination

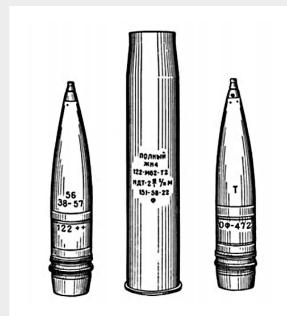
OF 472 122 mm projectile

Two recovered (unexploded) OF 472 projectiles were examined, along with two unfired OF 482 projectiles.

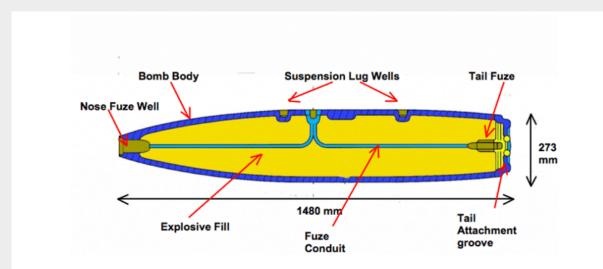
Section through the US Mk 82 GP bomb.

During the mission, cuts were made on two Mk 82 (500 lb) bombs and one Mk 84 (2,000 lb) bomb; each of these incorporated an M904 impact nose fuze, but no tail fuze. Due to limitations of time and equipment, none of the fuzes were cut and only a superficial examination was made of each nose section.

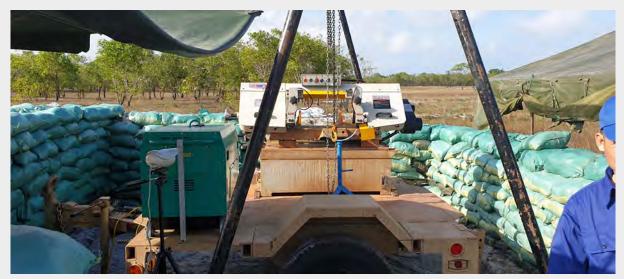
The mobile cutting system was set up in a sandbagged bunker area with the hoist and generator. The Wi-Fi camera system was very unreliable so another camera system with hardwire and LCD screen will be bought, as a replacement. This will be presented to VNMAC (estimated cost is US\$ 200).

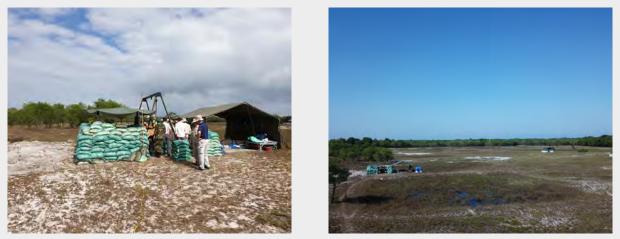
View of the cutting area and overall drone view of the range. VNMAC, BOMICEN and PMC sappers did an excellent job of following safety distances and having the site set up prior to our arrival

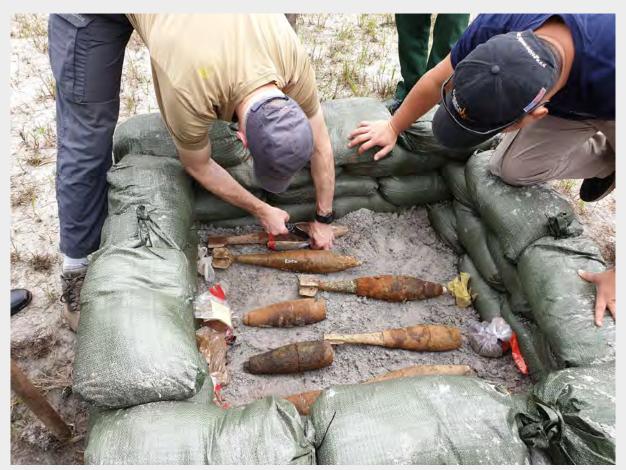
View of the 8 x US M374 81 mm mortars prior to cutting

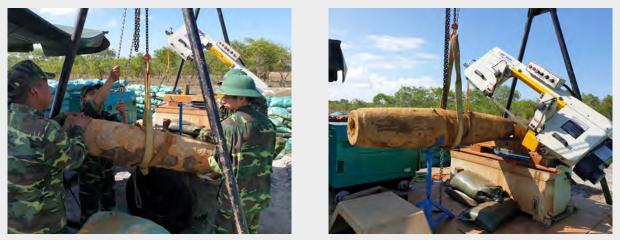
Hoisting and setting in place the Mk 82 500 lb bomb for cutting; note the use of the bomb cradle to help support the bomb as well as keeping the hoist cables connected while cutting. Each of the Mk 82 500 lb bombs had a crushed M904 PD fuze and there was no tail fuze in either one. We cut between 20 cm and 25 cm so that the booster cup was not cut through and still allowed us to make the cut large enough for the burnout process

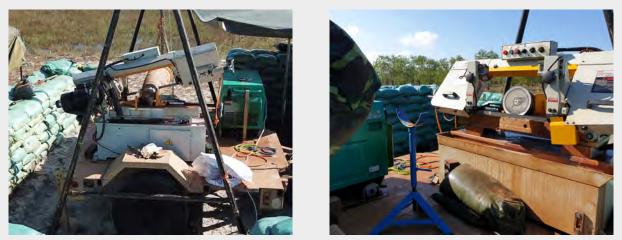
Drone view of the cutting of the Mk 82 500 lb bomb; image on the right shows the cut nose section. The cut took 12 minutes

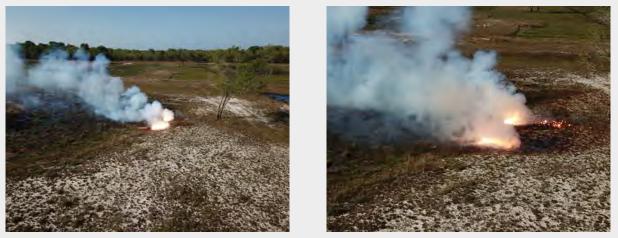
Burning out the main bodies of the 2 × Mk 82 500 lb bombs; the burnout lasted 22 minutes

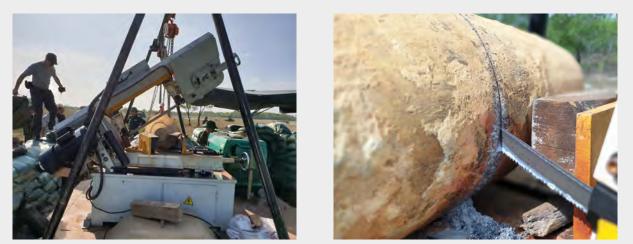
Front view of the cutting of the Mk 84. It was important to keep the bomb straight and as even as possible so as not to damage the cutter or the blade; image on the right shows the cutting blade with the metal lubricant evenly distributed throughout the length of the blade while cutting; the cut took 50 minutes due to the 22 mm thickness, and the slow drop and blade speed settings that we used for the cut.
